Return to Flight Implementation Plan introduced

JSC leads the way in developing a Thermal Protection System repair process

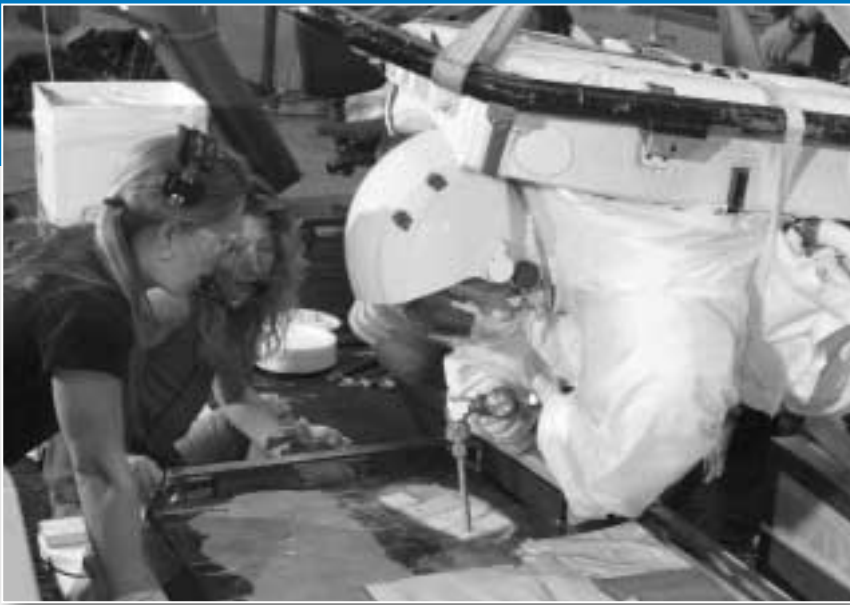
jsc2003e48795 Photo by Robert Markowitz

Extravehicular Activities (EVA) Operations Engineer Dina Barclay, right, participates in a suited evaluation of tile repair techniques in JSC's Space Environment Simulation Laboratory. EVA Operations Engineer Dana Weigel, left, conducts the evaluation and EVA Tools Engineer Lora Bailey assists.

One method researchers are using for tile-repair testing is called the "Under-fill Technique." This technique would work as follows:

- First, the area of the damaged site is measured. A depth gauge is used to get a sense of the volume of repair needed.
- The dabbing of a sticky foam brush inside the cavity absorbs broken tile dust and prepares the surface for the silicon material.
- The silicon material, applied with a large device similar to a caulk gun, patches the hole.

■ The astronaut uses a foam roller or foam brush to flatten peaks and high spots on the surface of the repair. After curing for 24 hours, the ablative goop will have hardened enough to protect the Shuttle during reentry.
